NIMS NOW 5

Accident Investigation File

50 years of NIMS accident investigations

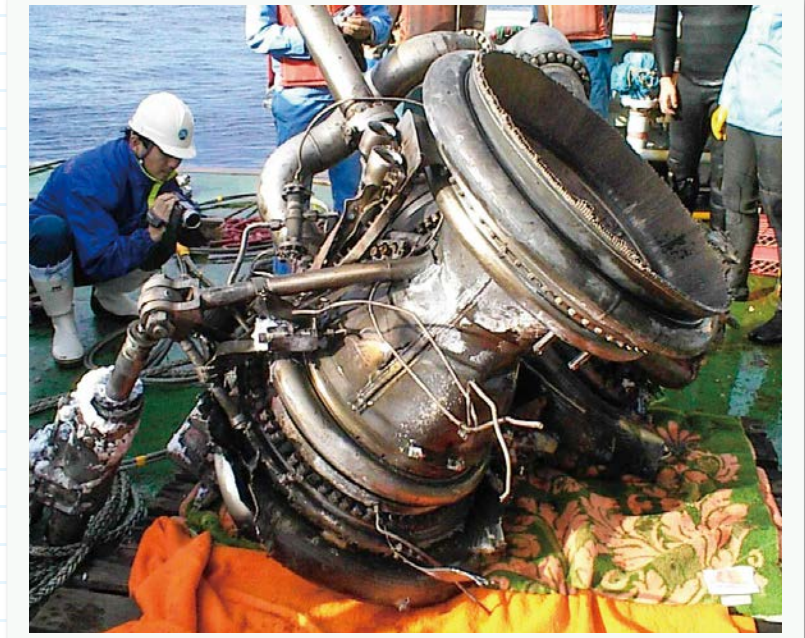
LE-7 engine after retrieval from the bottom of the sea
(photo provided by JAXA)

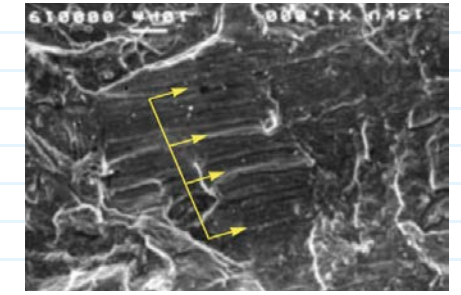
The SEM analysis revealed a pattern called striation on the fracture surface of the inducer (top-right photo on p. 9). This is characteristic of metal fatigue. The striation originated at a machining mark 15 micrometers deep on the surface of the inducer, clearly indicating that metal fatigue had developed from a scratch with a depth one quarter of the diameter of a human hair. A pattern called dimple was also observed on the fracture surface, and the configuration of this dimpling suggests that the fracture had occurred at an

The investigation team also calculated the forces that had been applied to the inducer based on the intervals between striation lines and found that it had been subjected to forces far exceeding its design specifications. The calculated value would have been insufficient to cause the inducer to crack, but the scratch on the surface was noteworthy. Any scratch on a metal surface induces a phenomenon called stress concentration, locally magnifying the intensity of forces in its vicinity. The inducer was believed to have eventually fractured when the already strong forces to which it had been subjected increased even further.

In addition to the rotating cavitation and unexpected oscillations, the forces were concentrated on the machining mark, ultimately causing the inducer to crack. These results were reported to the Space Activities Commission and the investigation was completed.

Inspection of the inducer revealed crystal grains larger than those found in rolled materials, making it slightly more susceptible to metal fatigue. Thus, the inducer's problems began with the quality of the material used to make them.

Fracture surface of the inducer inspected using a scanning electron microscope (SEM). Striation, a pattern characteristic of metal fatigue, is clearly visible on the fracture surface of the inducer.

Materials testing data obtained by NIMS is now reflected in JAXA's rocket design specifications. Rocket components now receive mirror finishing to ensure that even minor scratches are not present, and the design of the inducers has been changed to eliminate rotating cavitation. In 2001, H-IIA Rocket No. 1, equipped with an LE-7A engine, was successfully launched. The latest model, the H3 rocket, is scheduled to be launched

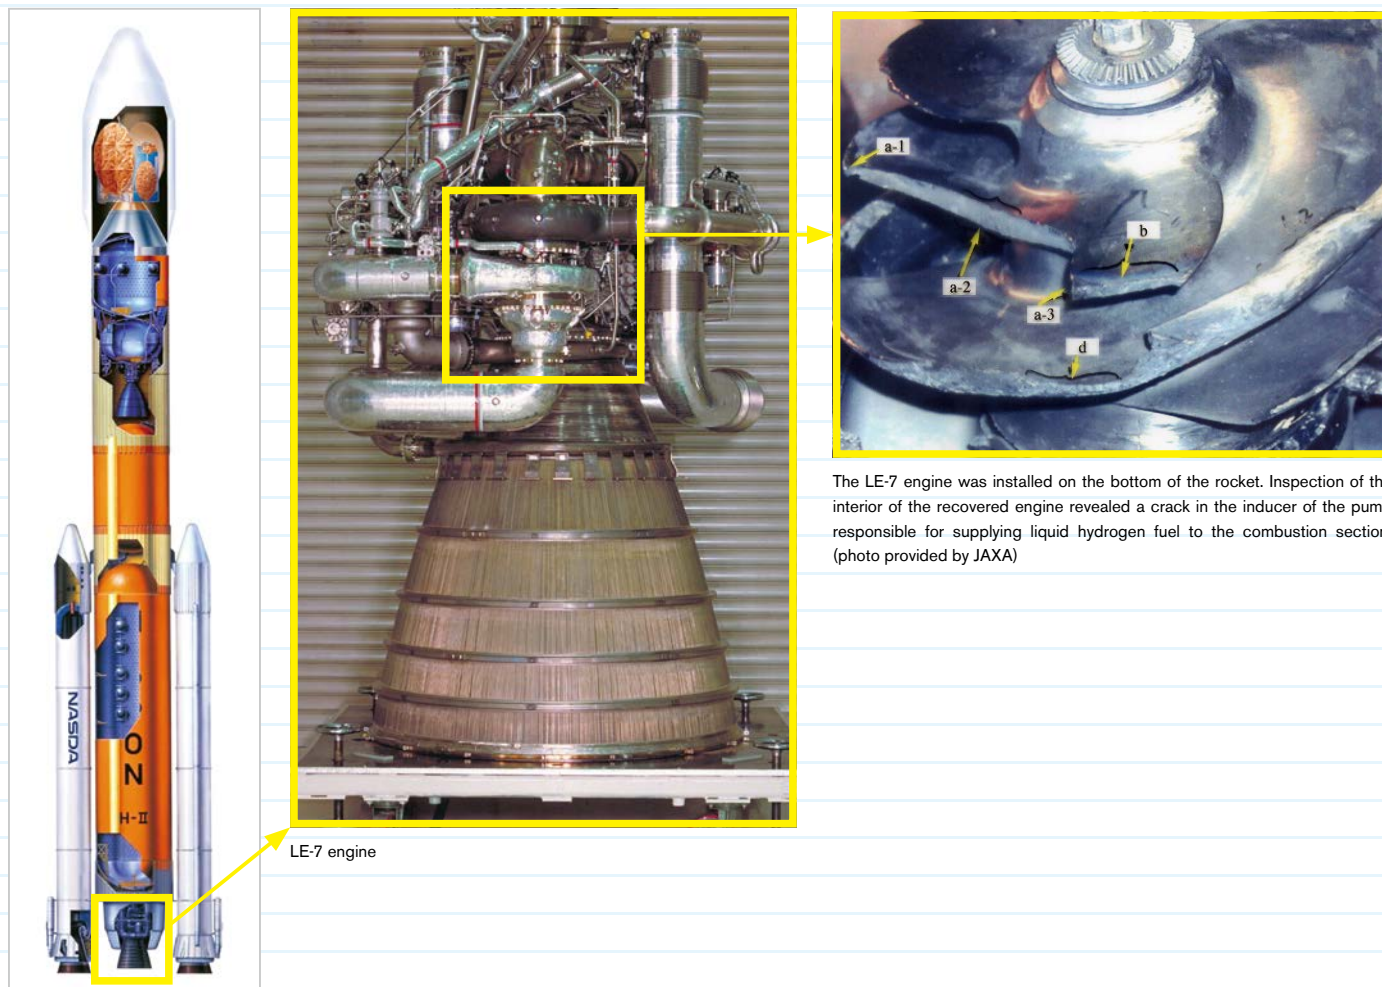
As predicted, an inspection of the engine revealed that one of the liquid hydrogen turbo pump's inducers, or wings, had cracked (photo on p.8).

The LE-7 engine was installed on the bottom of the rocket. Inspection of the interior of the recovered engine revealed a crack in the inducer of the pump responsible for supplying liquid hydrogen fuel to the combustion section. (photo provided by JAXA)

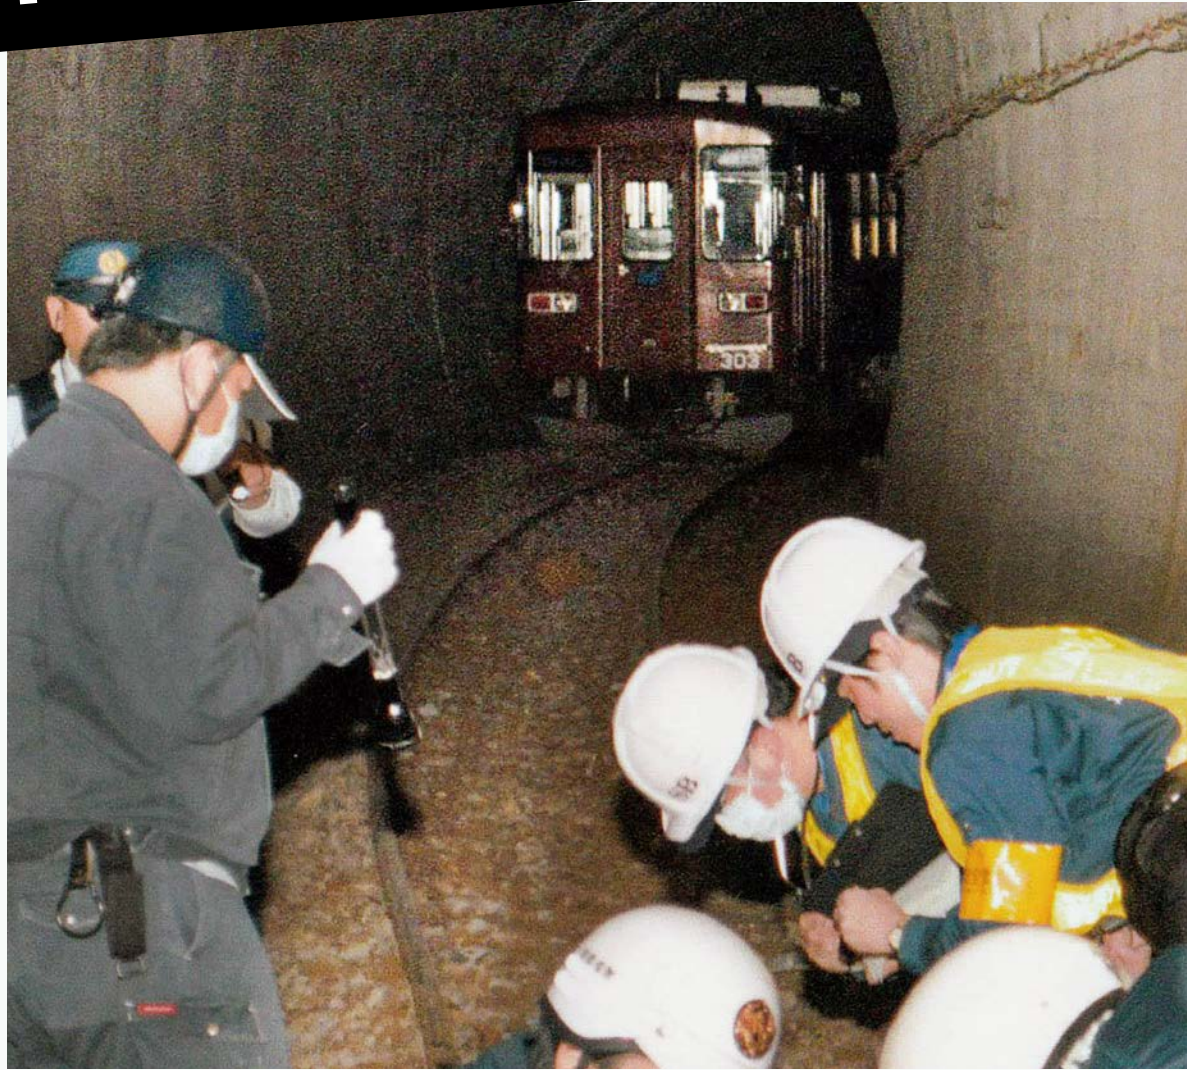
Onsite investigation by the police and other investigators on the day after the accident (photo provided by Sankei Shimbun Co., Ltd.)

The following day, the Ministry of Land, Infrastructure, Transport and Tourism's Japan Transport Safety Board dispatched investigators to the accident site. It was obvious that the left rail, i.e., the outer rail on the curve, had broken. However, it was necessary to find out why so that effective measures could be taken in response. Accordingly, in September 2016, the Japan Transport Safety Board requested that NIMS conduct a more detailed investigation.

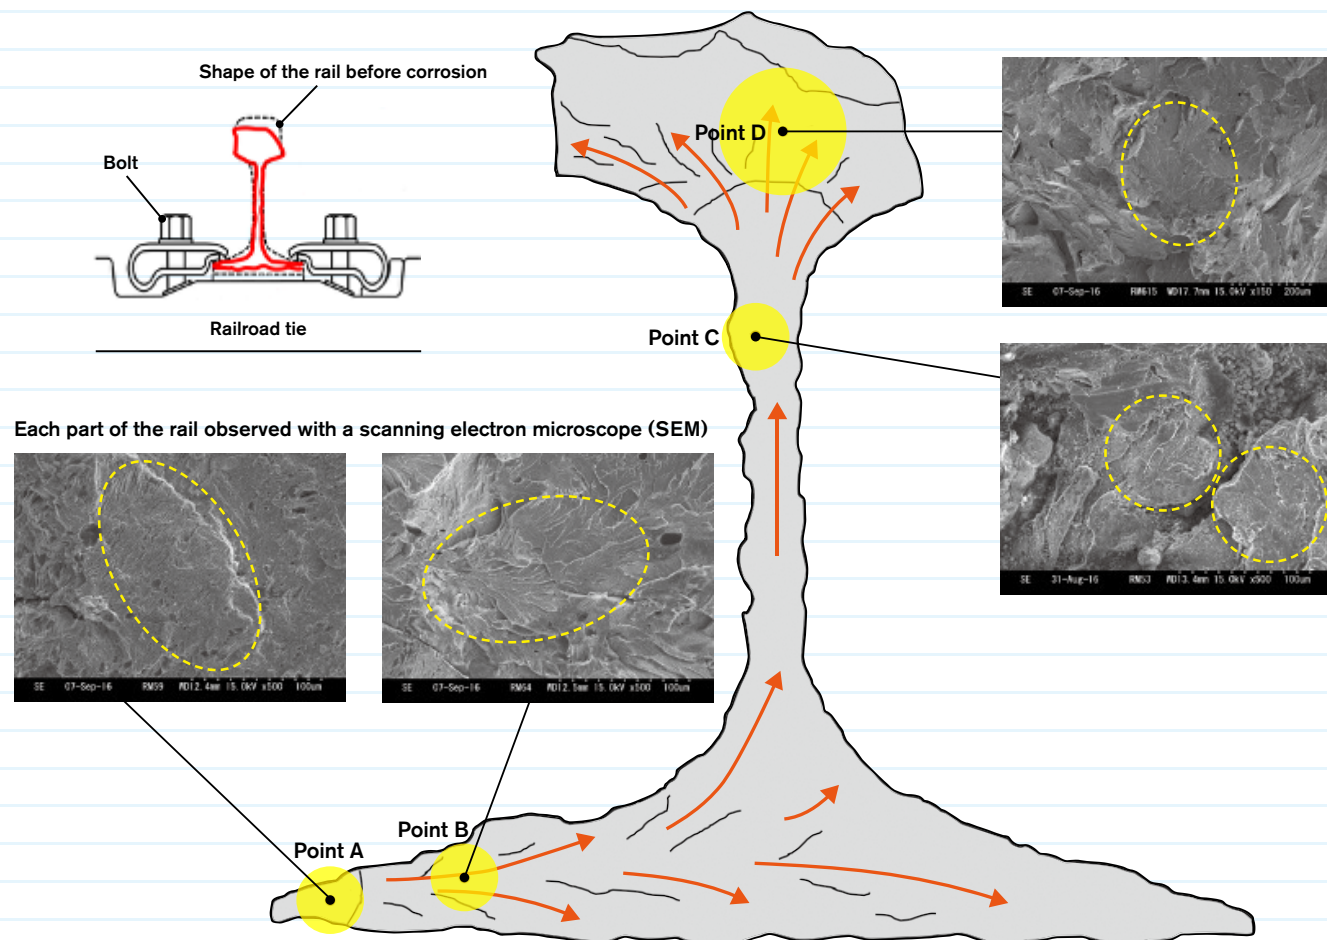
First, a striped pattern was found at the corner of the lower part of the rail (p. 14, Figure - Point A). This is called striation, which shows progressive fatigue at this point. The accident site is a curve to the right and the influence of centrifugal force on the rail was significant, in addition to the weight of the train. In other words, the corner on the outer side of the curve was subject to heavy loads.

At the same time, a cleavage pattern broadly covered the adjacent area (Figure - Point B), which means that this area fractured all at once due to a shock. Cleavage patterns were also observed on the rail body (Figure - Point C) and the upper part (Figure - Point D). What matters is the cause of the cleavage: due to fatigue on the lower part or a crack on the upper part.

As a result, the river pattern on the fracture surface revealed that the fracture started from the lower part and continued to the upper part. As Furuya initially assumed, it was clear that the crack developed due to fatigue and corrosion on the lower part of the rail and that the cleavage occurred all at once when the rail's limits were exceeded, leading to the rail fracture. It was concluded that the crack on the upper part occurred after the rail fractured.

Striation, evidence of metal fatigue, was observed at Point A, while cleavage patterns showing that cracks occurred due to a strong force applied instantaneously were found at Points B, C and D. The river pattern at Point B determined the direction in which the crack developed.

In its report, the Nagaragawa Railway Co., Ltd. commented, "We did not imagine that the rail would fracture due to corrosion in such a short time." The rail was replaced and measures were implemented to prevent water seepage within the tunnel.
